# Manhole Inspection Summary

Manhole # S33OO\_004MH

Insp Date: **4/23/07 11:30 AM**

**Location** Address: **22 24TH ST**

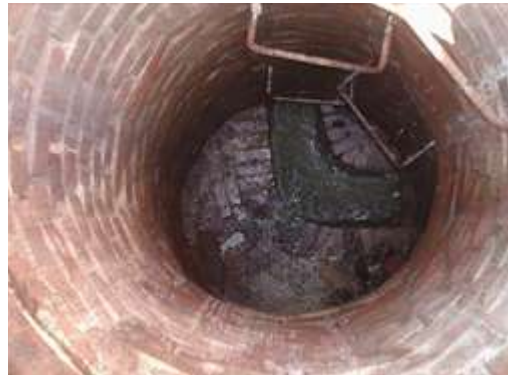
Top View

Corroded steps. Barrel infiltration. Bench debris.

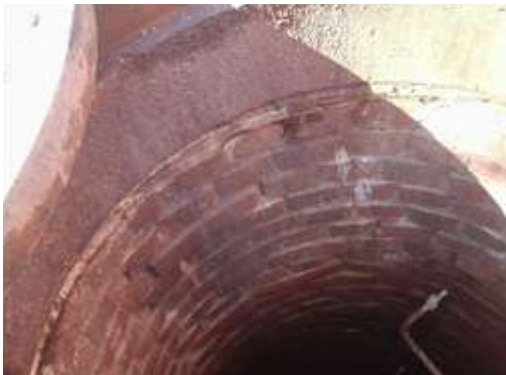
Defect

Frame leaks. Adjustment deterioration and infiltration.

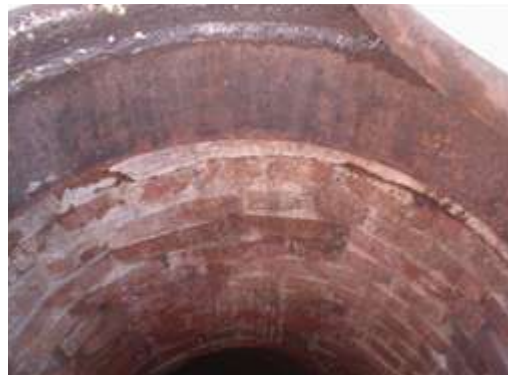
Defect

Adjustment deterioration and infiltration.

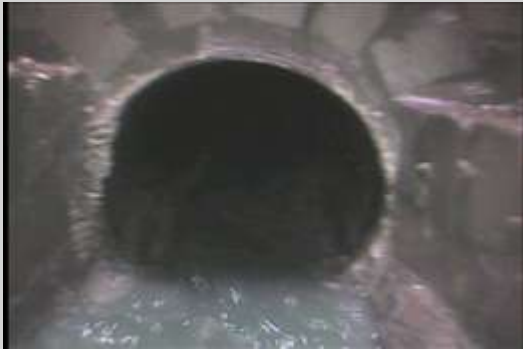
### 12 in. Circular Gravity Sewer Pipe Out @ 12 O'Clock

Infiltration: **None** Pipe Seal Cond: **Unknown**

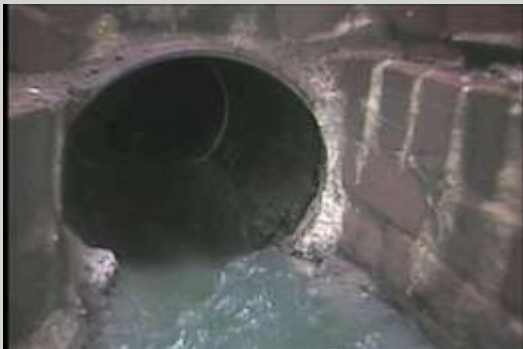
### 12 in. Circular Gravity Sewer Pipe In @ 3 O'Clock

Infiltration: **None** Pipe Seal Cond: **Unknown**
